# 自动化监测与人工监测的桥梁 与隧道监测

### 中环湾仔绕道及东区走廊通道 (CWB)

### Central - Wan Chai Bypass and Island Eastern Corridor Link

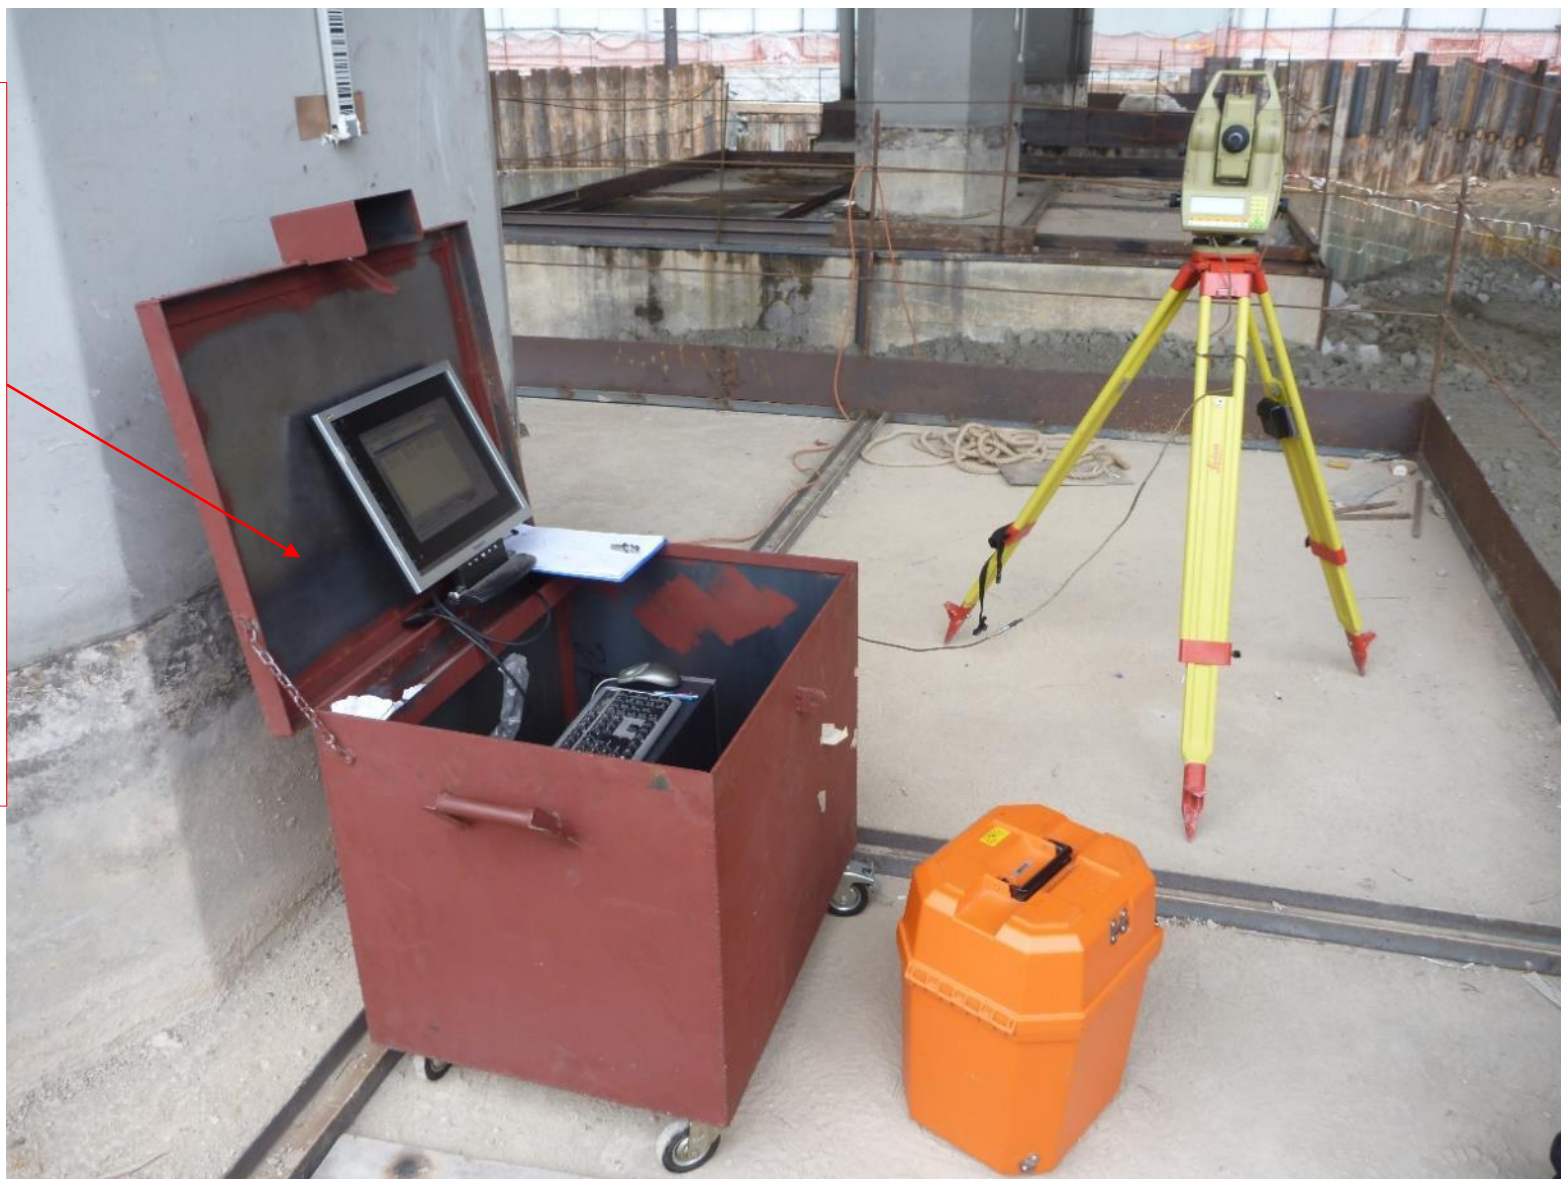
We have  
Computer, UPS,  
communication  
device, Geomos  
Monitor and  
Geomos Analysis  
inside the box

我们使用了计算机、  
UPS\通讯设备、  
GeoMoS的监测器  
和分析器。都安装  
在这个箱子里。

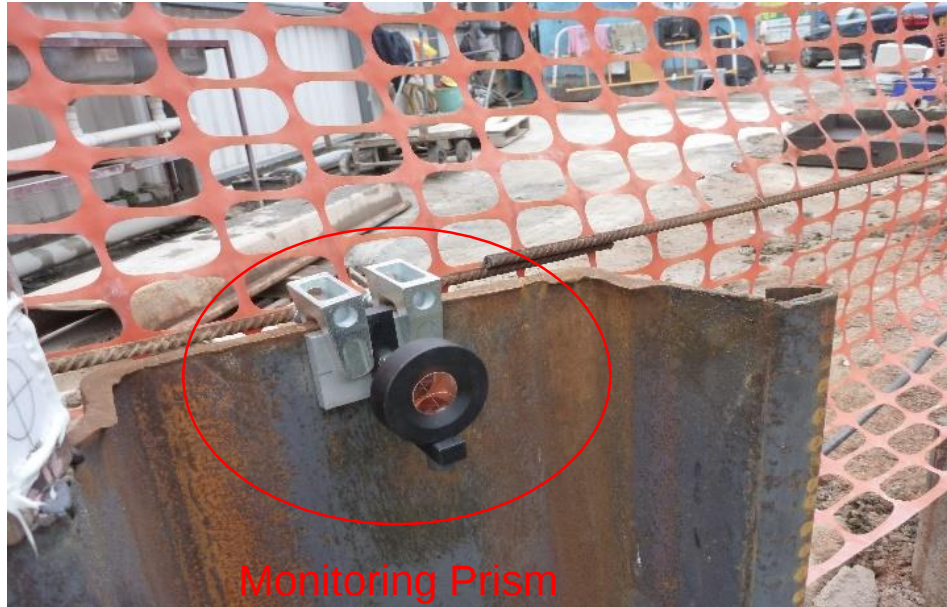
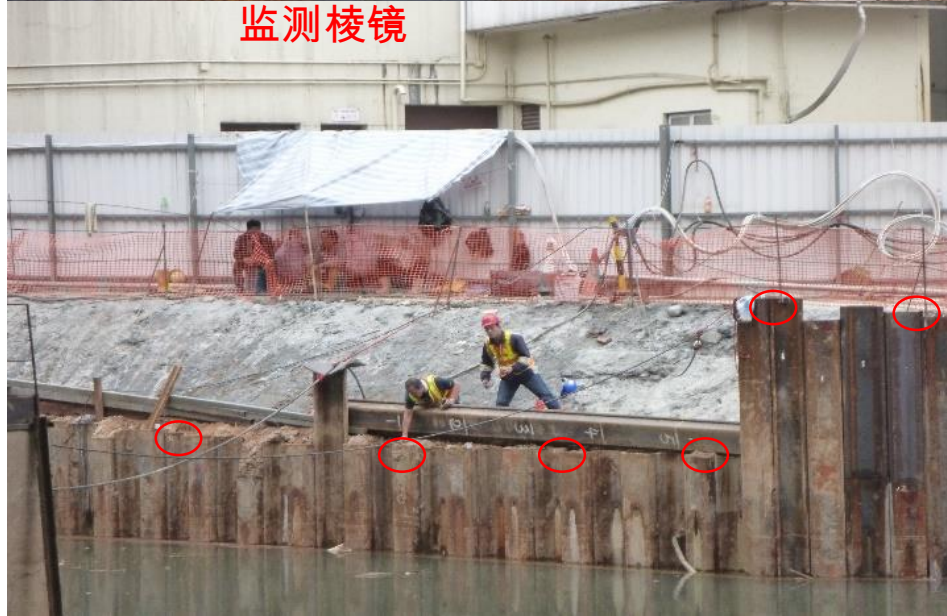
Monitoring Prism  
监测棱镜

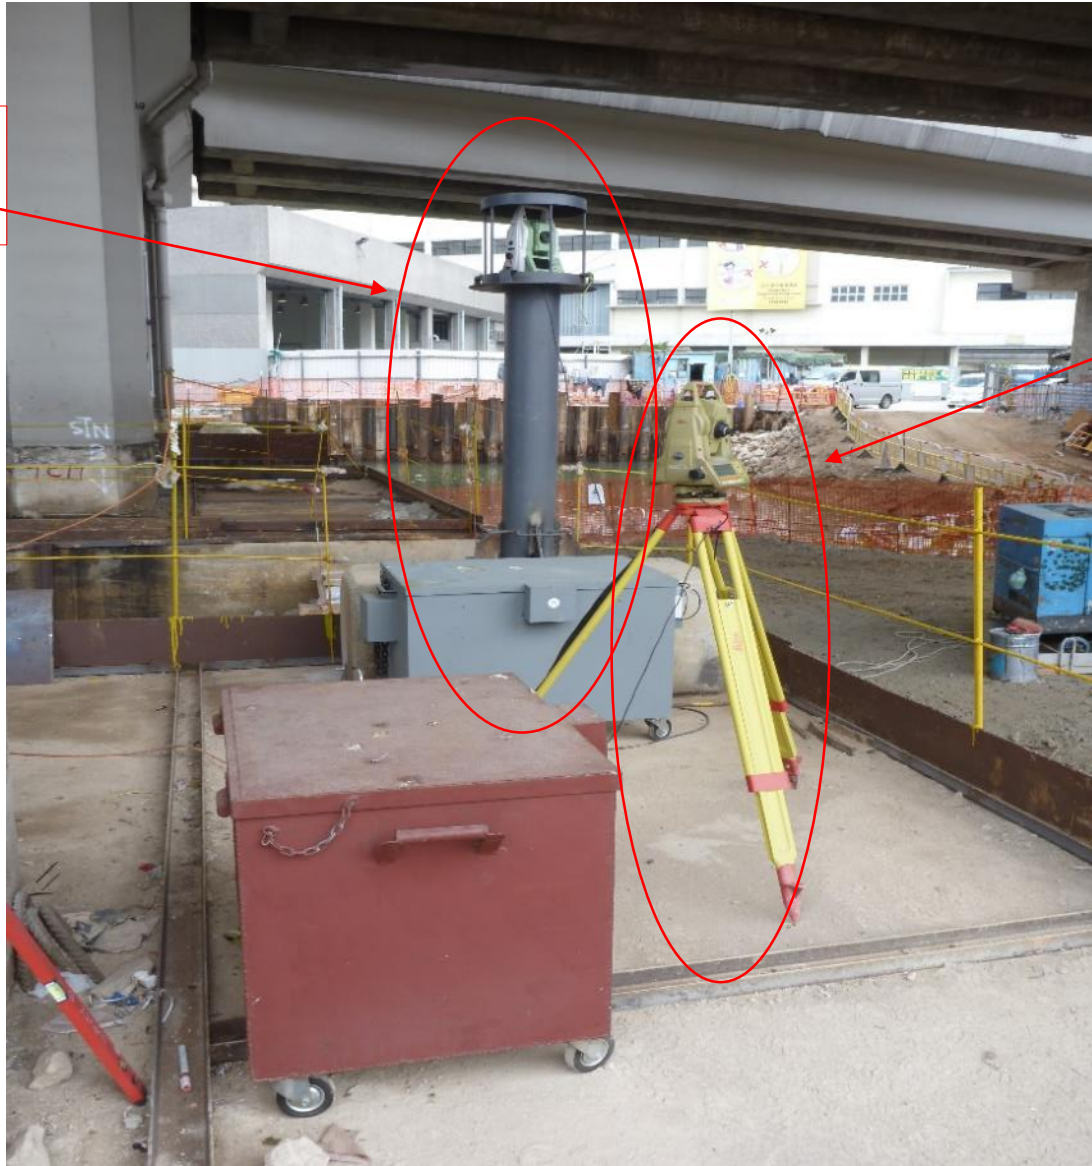
This is Permanent Setup  
这是永久设站点

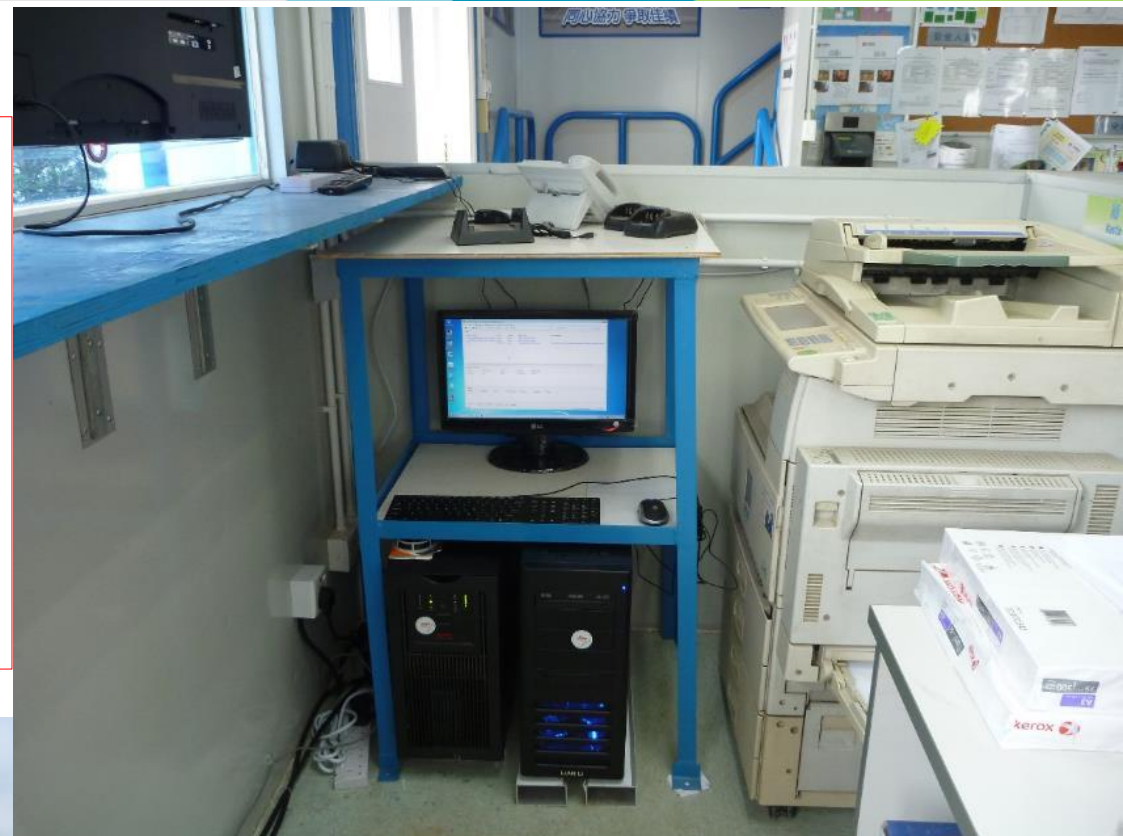
We have  
Computer, UPS,  
Geomos Monitor  
and Geomos  
Analysis inside  
the box

在箱子里安装了  
电脑、UPS、  
GeoMoS的监测  
器和分析器

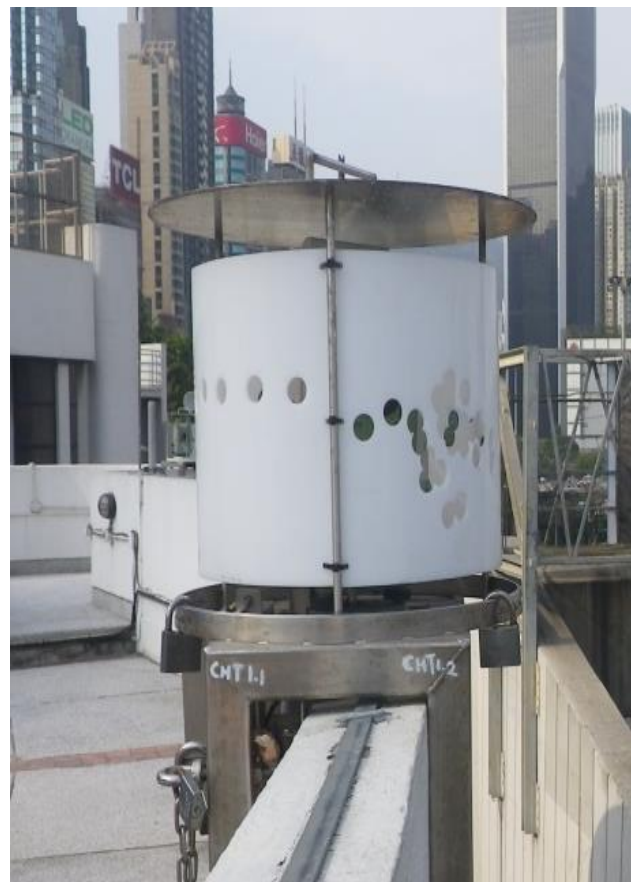
- 情况: 增加 PVC 罩子
